Illicit Discharge Detection & Elimination Program

2023 Field Screening Program

VILLAGE OF
COMBINED LOCKS
OUTAGAMIE COUNTY, WISCONSIN

FEBRAURY 9, 2024

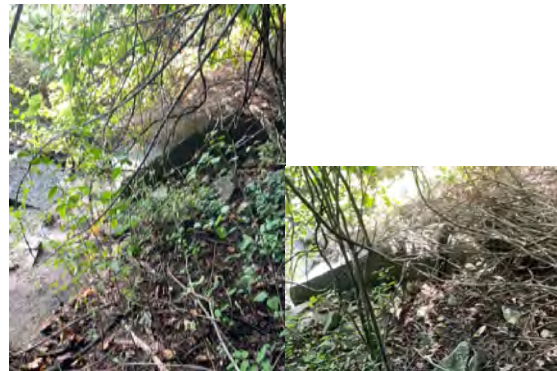
MS4 JURISDICTION	OUTFALL TYPE	ID
Village of Combined Locks	Minor	G3g1-1

- Outfall G4j1(1)-2 was observed as having a large crack in the pipe.
- Outfall G3g1-1 was observed as having an endwall that is dislocated form pipe.
- Outfall G3g3-1 has an endwall that is completely rusted through and non-existent.

Non-Illicit Discharge Concerns: Endwall walking away see pic
 Other Comments: N/A

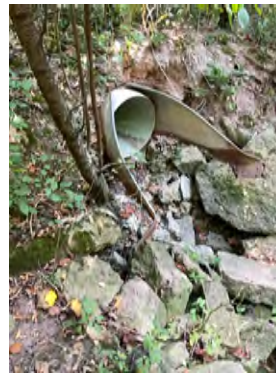
MS4 JURISDICTION	OUTFALL TYPE	ID
Village of Combined Locks	Minor	G3g3-1

Non-Illicit Discharge Concerns: Endwall gone see pic

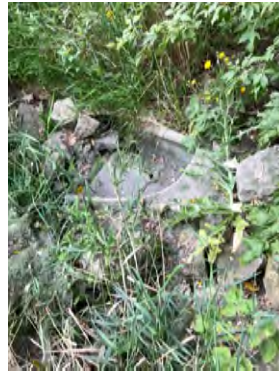
MS4 JURISDICTION	OUTFALL TYPE	ID
Village of Combined Locks	Minor - Supplemental	G4j1(1)-2

Other Comments: Pipe cracked
