Illicit Discharge Detection & Elimination Program

2023 Field Screening Program

VILLAGE OF
COMBINED LOCKS
OUTAGAMIE COUNTY, WISCONSIN

FEBRAURY 9, 2024

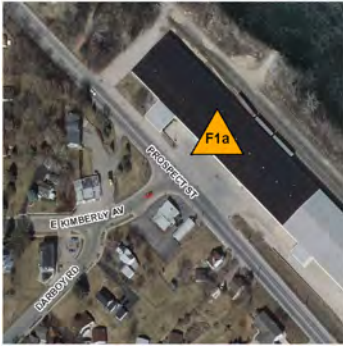
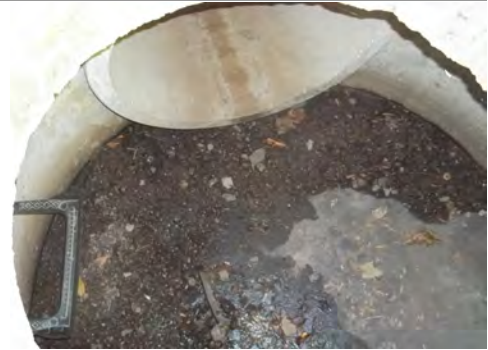
MS4 JURISDICTION	OUTFALL TYPE	ID
Village of Combined Locks	Minor	F1a-1

Flow Description: Moderate	Total Chlorine : 0.02
Approximate Flow: 0	Free Chlorine (mg/l): 0
Flow Temp (°C): 19.16	Total Copper (mg/l): 0.03
pH: 8.3	Total Phenol (mg/l): 0
Ammonia (mg/l): 0.05	Detergents (mg/l): 0.13
Conductivity: 290

Overall Outfall Characterization
Potential for Illicit Discharge: Unlikely

Other Comments: Tested from manhole, sample taken from 18" west

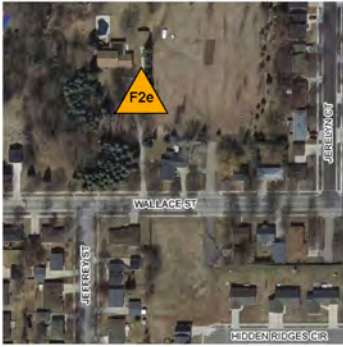
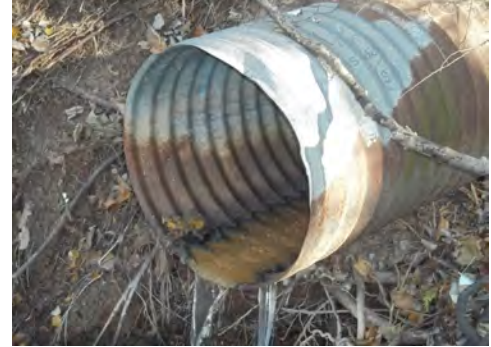
MS4 JURISDICTION	OUTFALL TYPE	ID
Village of Combined Locks	Minor	F2e-1

Flow Description: Trickle	Total Chlorine : 0.05
Approximate Flow: N/A	Free Chlorine (mg/l): 0.01
Flow Temp (°C): 14.72	Total Copper (mg/l): 0
pH: 8.1	Total Phenol (mg/l): 0
Ammonia (mg/l): 0	Detergents (mg/l): 0.02
Conductivity: 1,080

Overall Outfall Characterization
Potential for Illicit Discharge: Unlikely

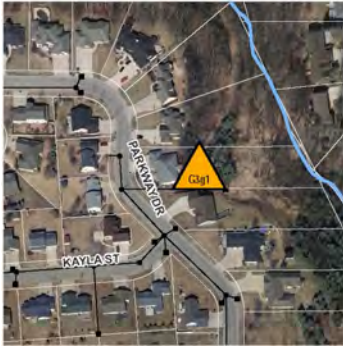
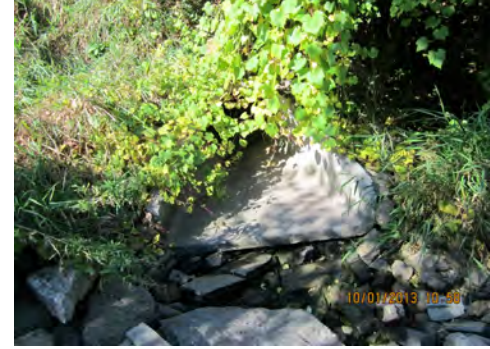
MS4 JURISDICTION	OUTFALL TYPE	ID
Village of Combined Locks	Minor	G3g1-1

- Outfall G4j1(1)-2 was observed as having a large crack in the pipe.
- Outfall G3g1-1 was observed as having an endwall that is dislocated form pipe.
- Outfall G3g3-1 has an endwall that is completely rusted through and non-existent.

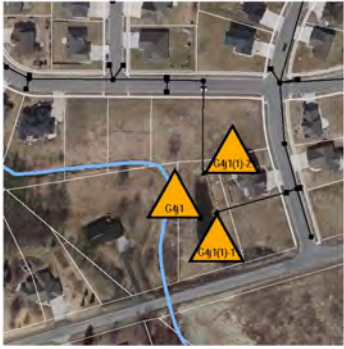
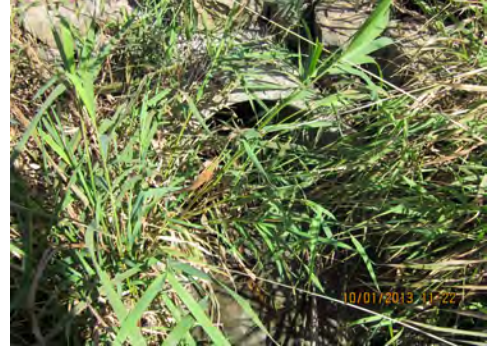
MS4 JURISDICTION	OUTFALL TYPE	ID
Village of Combined Locks	Minor - Supplemental	G4j1(1)-2

Other Comments: Pipe cracked
